Request for extension of the deadline for fulfilment of obligations under Article 5 of the Convention on the Prohibition of the Use, Stockpiling, Production and Transfer of Anti-Personnel Mines and on Their Destruction

Denmark

June 2010

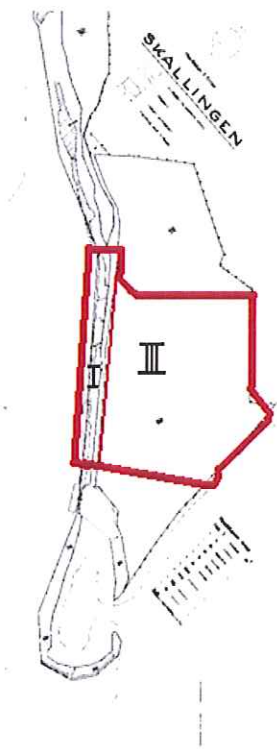
Figure 1, Original minefields included in Area 3.

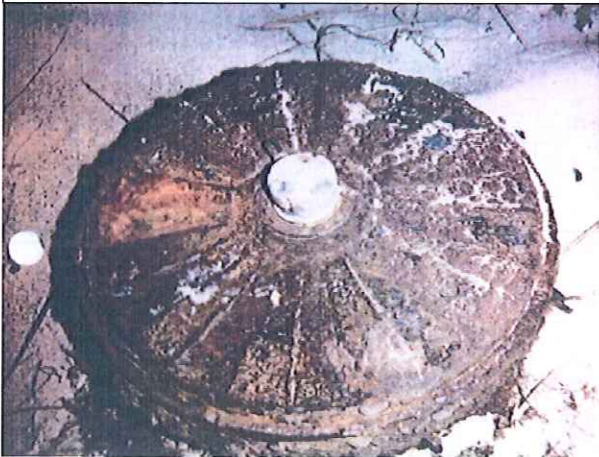
T-35 Anti Tank Mine
Only few T-35 were laid and none were found in Area 1 or 2. The findings from T-42 mines found in Area 1 (see below) would expectedly be the same for T-35, but it is unknown if the T-35 cover offers the same protection against the environment as the T-42

Picture 1: T-35 mine. This picture is not from the new clearance project on Skallingen

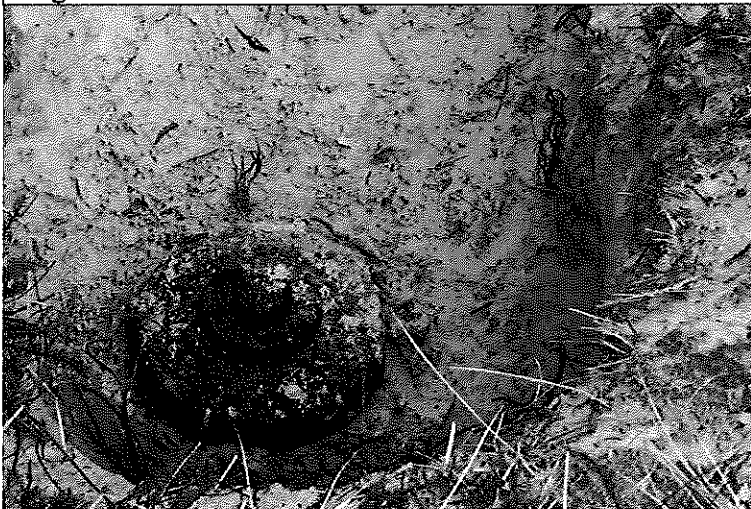
Picture 2: T-42 mine found in Area 1.

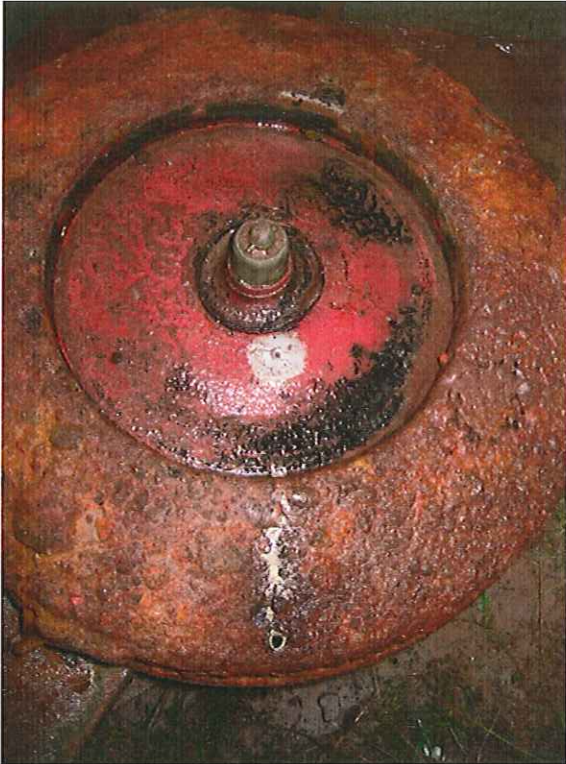
Picture 3: T-42 mine from Area 1. The mine has been opened with an abrasive water cutter, hence the water and sand on the fuse.

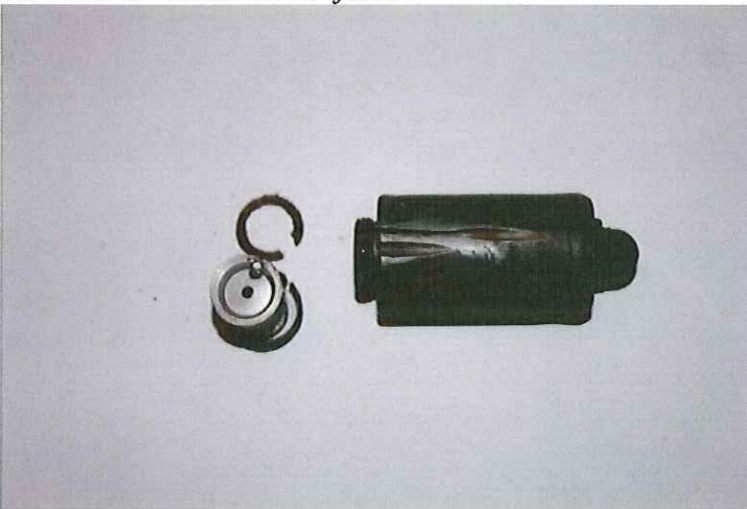
Picture 4: T-Mi.Zdr.42 fuse recovered from a T-42 mine in Area 1. The damages on the fuse body are made in the water cutting process.

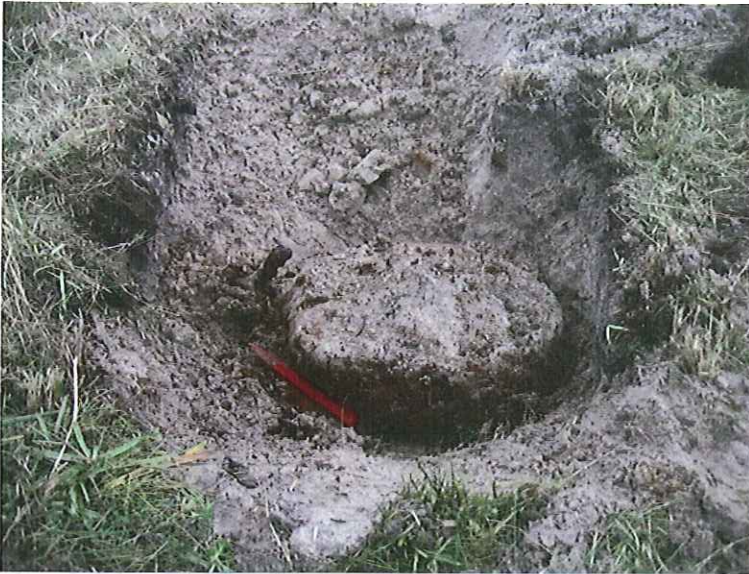
Picture 5: T-42 found during the technical survey in Area 3 marshland.

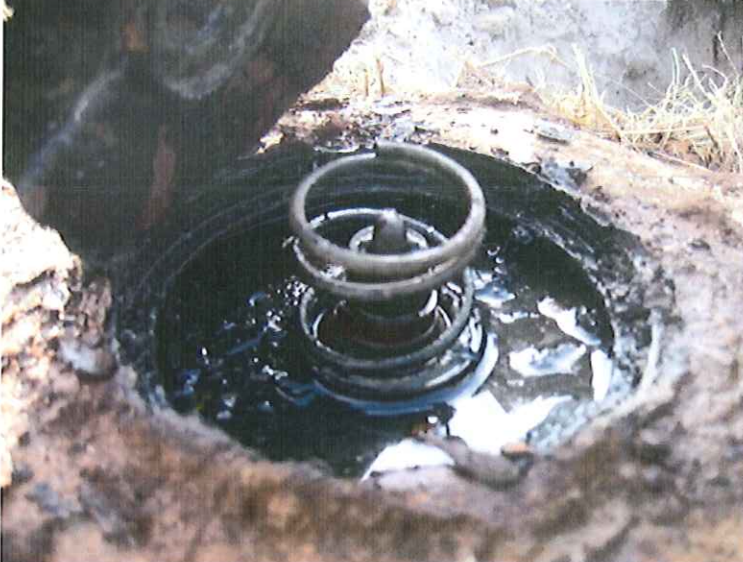
Picture 6: The inside of the T-42 found during the technical survey in Area 3 marshland. The fluid is oil from the attempt to loosen the fuse from the fuse well. When opened, the inside seemed unaffected by the wet environment in which the mine had been for 60 years.

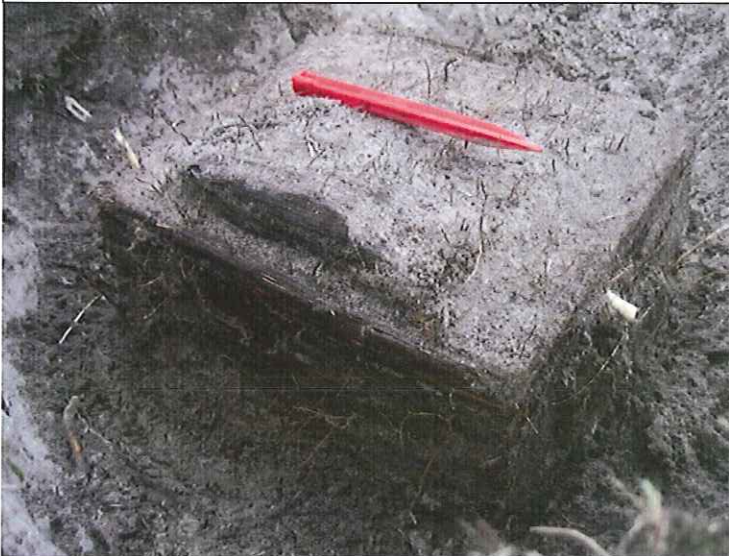
Picture 7: Holz-42 mine in Area 3 marshland.

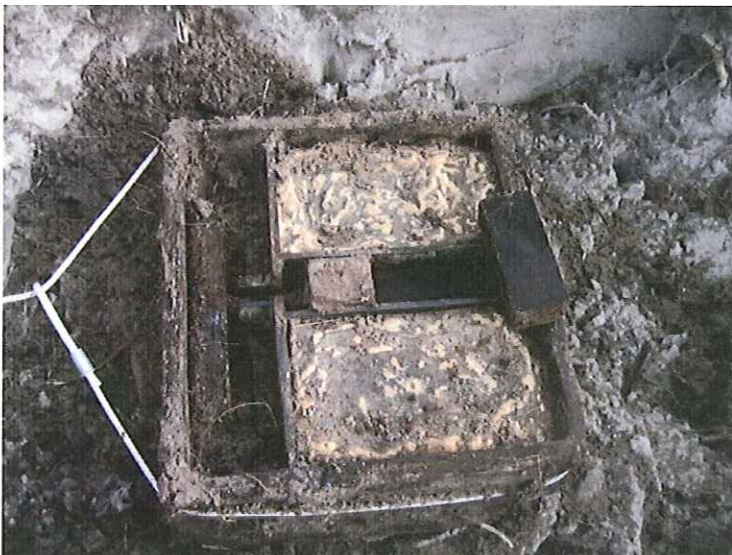
Picture 8: Holz-42 mine in Area 3 marshland, opened.

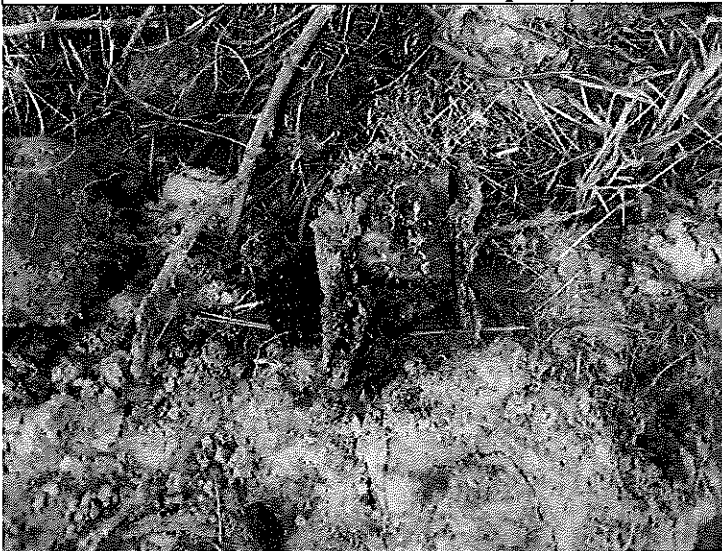
Picture 9: Schütz-42 mine from Area 3 marshland.

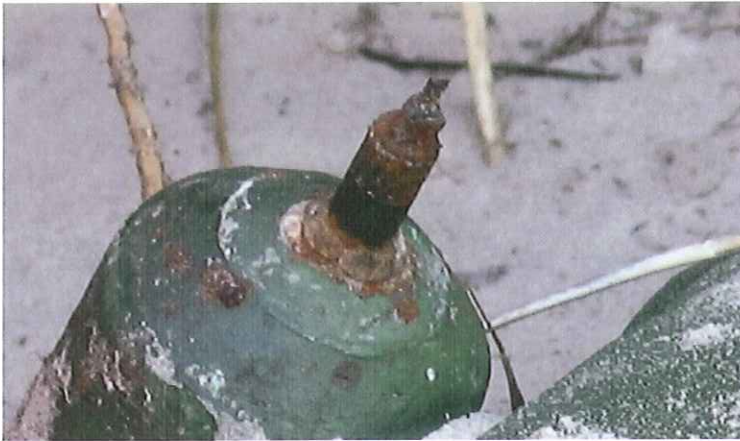
Picture 10: Stockmine from the dunes in Area 1.

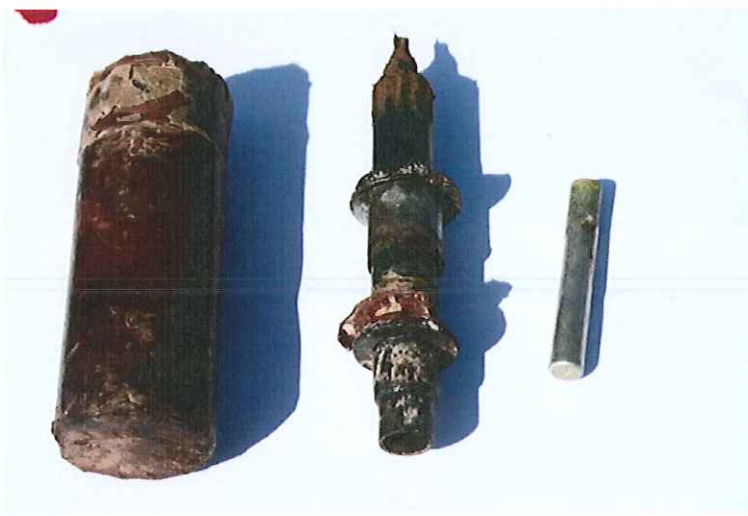
Picture 11: Main charge, ZZ-42 fuse and detonator from Stockmine found in the dunes.
